**AN ARCHAEOLOGICAL SURVEY FOR THE  
ZAPATA COUNTY WASTEWATER TREATMENT PLANT EXPANSION  
PROJECT IN WEST-CENTRAL ZAPATA COUNTY, TEXAS**

*Antiquities Permit 7336*

Contract Report Number 272

BVRA Project Number 15-06

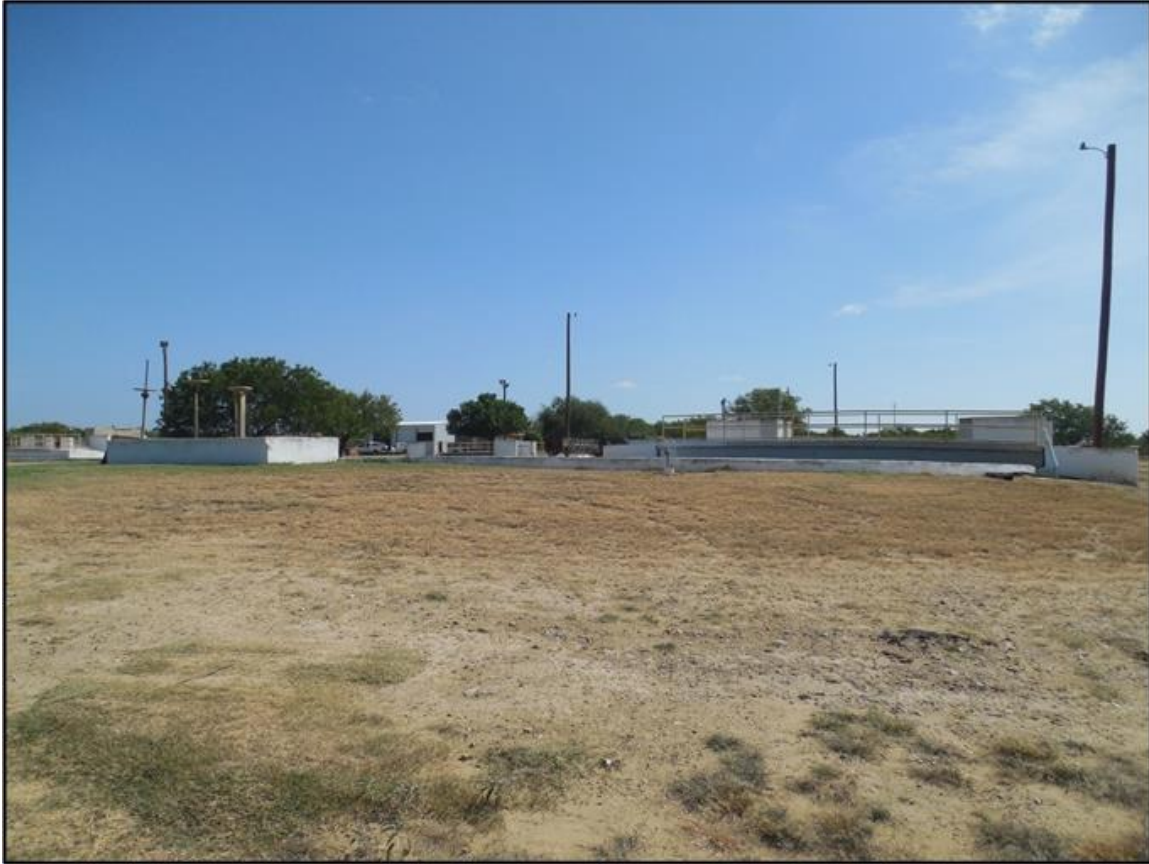
Figure 2. Existing Wastewater Treatment Plant.

In addition to the plant having reached 90% of its capacity, the life expectancy of the 0.8 MGD wastewater plant has expired. Both existing oxidation ditches have major structural damage present that prevents Zapata County Personnel from operating the facility properly. Additionally, most of the mechanical components throughout the plant are worn out and need total replacement. For these reasons, the proposed 1.6 MGD wastewater treatment plant improvement project shall consist of constructing a new headworks facility, two new aeration basins, two new clarifiers, one chlorination basin, and a new office with TCEQ compliant laboratory. These new plant improvements will be designed and constructed in strict accordance with the rules and regulations set forth by TCEQ. In addition, the planned improvements will be designed to meet the existing 5/15 discharge permit requirement. The design flow of 1.6 MGD and 2-hr peak flow of 6.0 MGD were carefully calculated from existing plant data as required by Rule §217.34 (Re-Rating, Expanding, or Materially Altering an Existing Facility)."

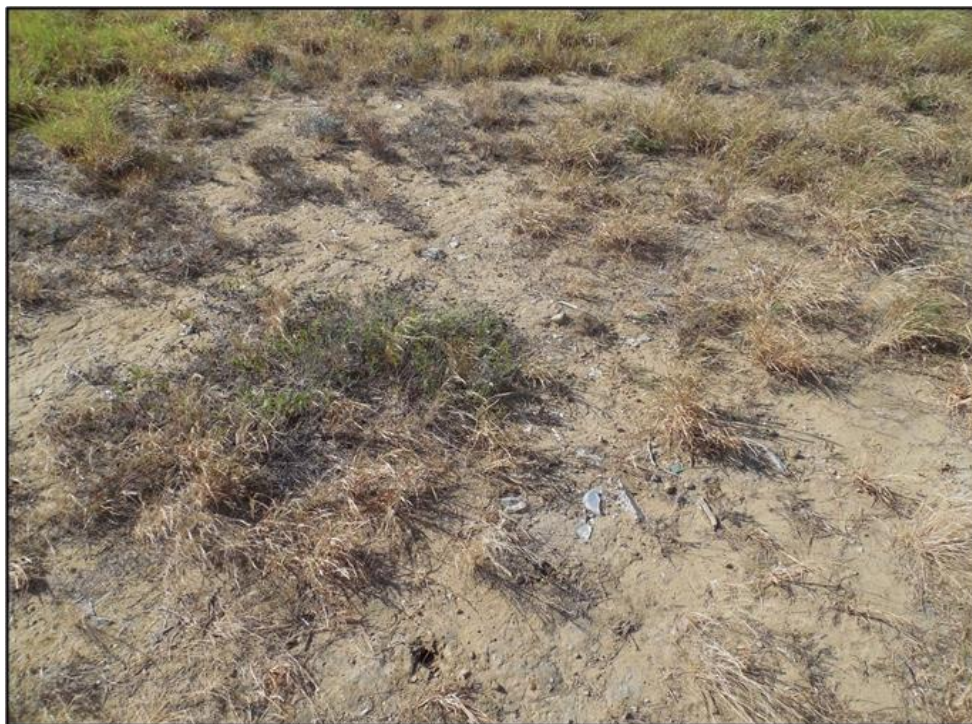
Figure 4. Typical Surface Exposure.

The area investigated had been cleared of all major vegetation through grading, a process that uses an excavator with a grading blade. This method disturbs at least six inches of the topsoil. The APE is on sloping terrain that drops about 20 feet from the east to west. In parts of the site, mainly towards the west, sandstone bedrock crops out at the surface. The entire site was fenced with modern chain link fencing. Other disturbance including installation of a two-inch waterline. This line was placed in a trench 24 in. wide and 26 in. deep. One pipe parallels the fence that forms the northwest boundary and the disturbance associated with this waterline extends at least 5 feet from the fence. The other waterline is a six-inch pipe that was installed to provide sufficient pressure to the existing belt press. This six-inch line comes out from the belt press towards the southwestern property/fence line and travels at an eight foot offset towards the most southwesterly corner. From here, the six-inch line changes direction and travels northeast along the same fence line for about 550 ft, before it turns to the southwest and eventually connects with another six-inch waterline at Madison Street.

The site of the proposed expansion of the wastewater treatment plant was the focus of this investigation. It is 4.58 ac. in size and fenced. When we arrived at the site, we were met by Carlos Trevino (Utilities Director for Zapata County), Eloy Chapman (Maintenance Supervisor), Mike Bonoan, Kiko Valadez, and Tino Zapata. The first step was to walk over the area in an attempt to identify artifacts and features that might be present on the surface. The surface survey was carried out by walking randomly over the entire area and stopping to inspect areas that were devoid of vegetation. We entered the tract in the northwest quadrant. Our first observation was sandstone cropping out at the surface. Overall, surface visibility was excellent (Figure 4).

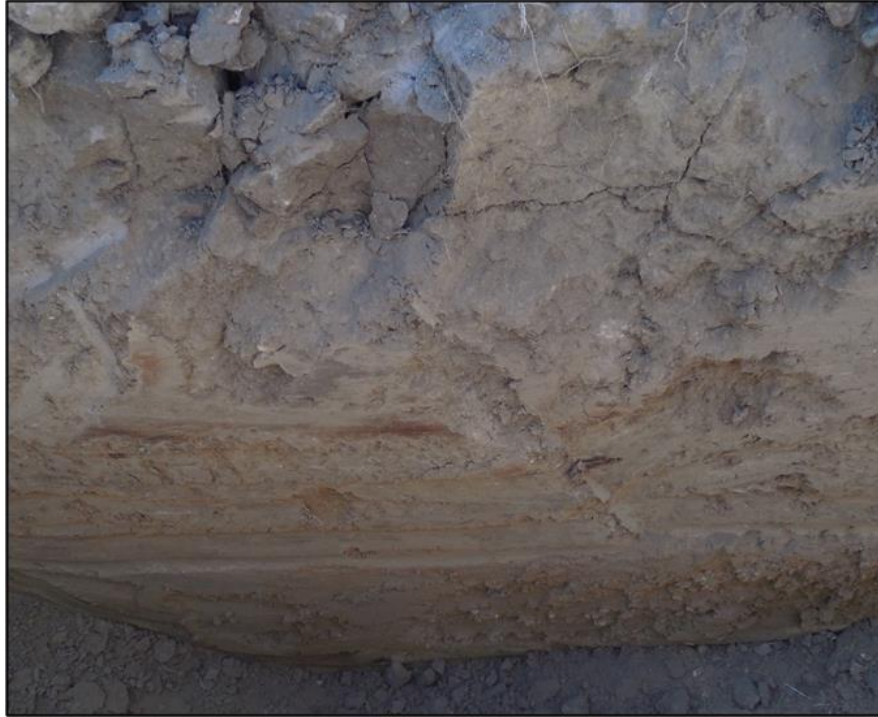
Figure 5. Profile of Backhoe Trench 2.

Because the surface had been disturbed through grading, we decided a series of backhoe trenches would be the best course of action since the A horizon was not only disturbed but reported to be shallow. The first three backhoe trenches were excavated parallel to the fence that borders the southern side of the tract and each trench was oriented from west to east. The shallow depth of the A horizon was quickly confirmed, but the trenches (except for Backhoe Trench 6) were dug from 90 cm to 179 cm, well into the B horizon (Appendix I). The profiles were checked for cultural materials that might indicate a buried site or staining that might be an indication of a fire (cultural or natural). The profiles in five of the six trenches were similar. Figure 5 depicts the profile for Backhoe Trench 2.

(looking south)

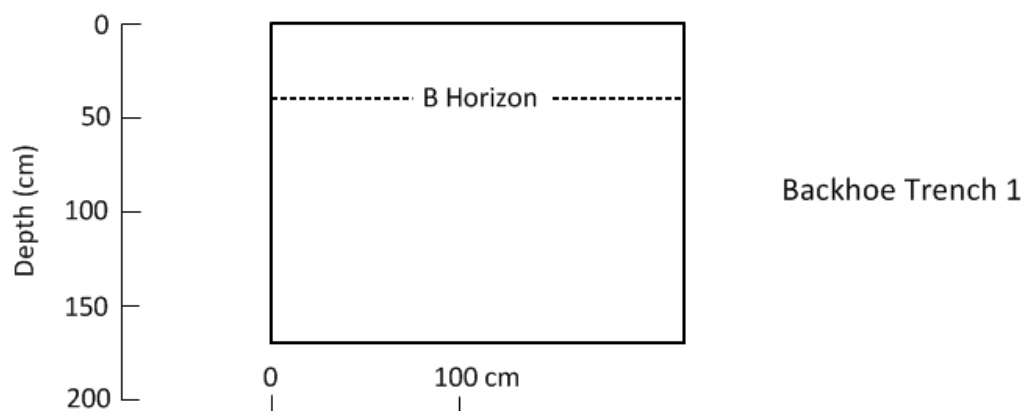
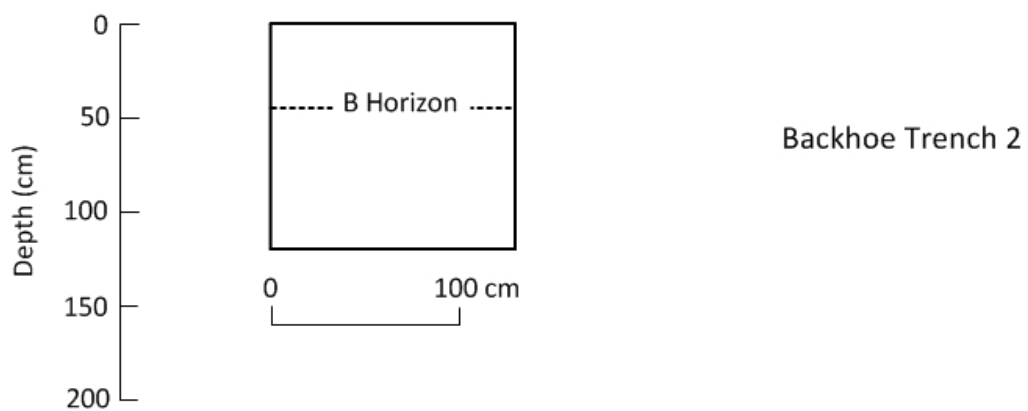
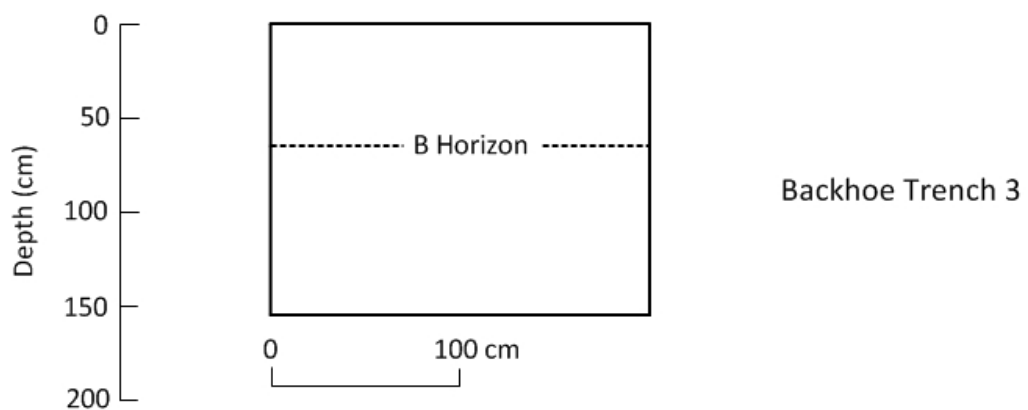
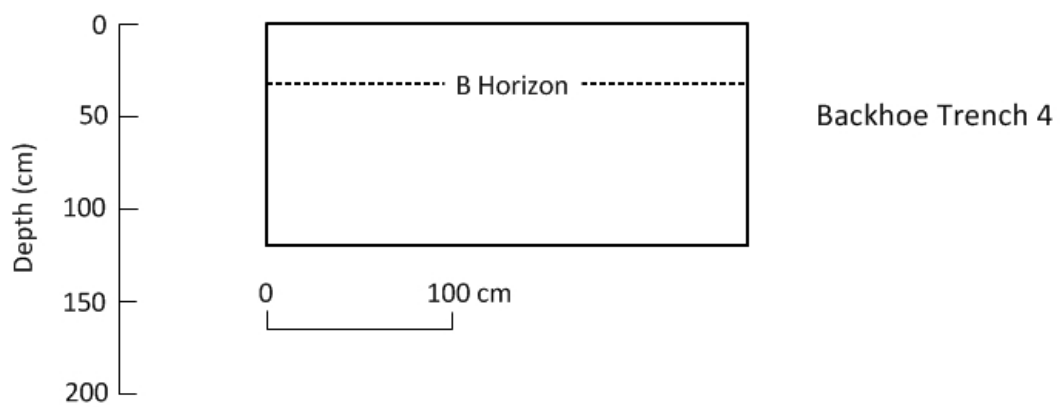
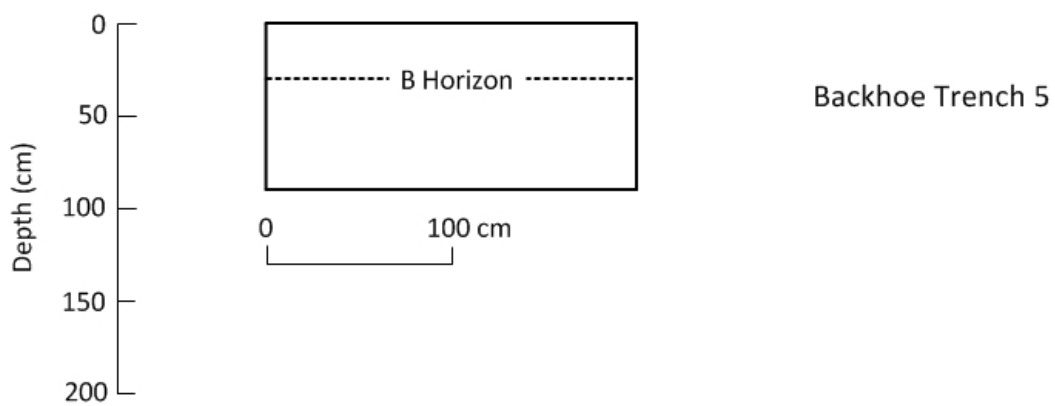
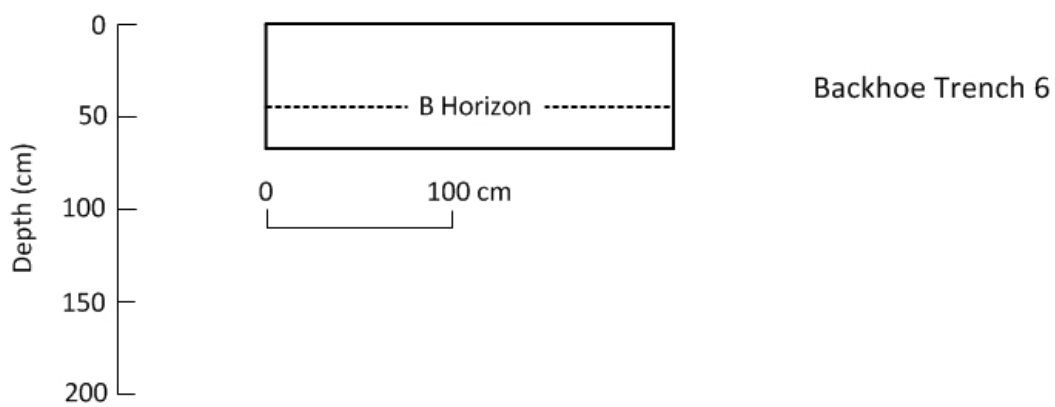
BACKHOE TRENCH PROFILES

<b>BT NO.</b>	<b>DEPTH OF TRENCH</b>	<b>DEPTH TO B HORIZON</b>	<b>COMMENTS</b>
1	1.70 m	40 cm	sandy loam over clayey subsoil
2	1.20 m	45 cm	sandy loam over clayey subsoil
3	1.55 m	65 cm	sandy loam over clayey subsoil
4	1.20 m	33 cm	sandy loam over clayey subsoil
5	0.90 m	25 cm	sandy loam over clayey subsoil
6	0.67 m	57 cm	sandstone at the surface

\* No cultural materials in any of the trenches.
